Accuracy and Precision of High-Speed Field Measurements of Pavement Surface Rutting and Cracking

Pedro A. Serigos, MSE, MSStat - *serigosp@utexas.edu*

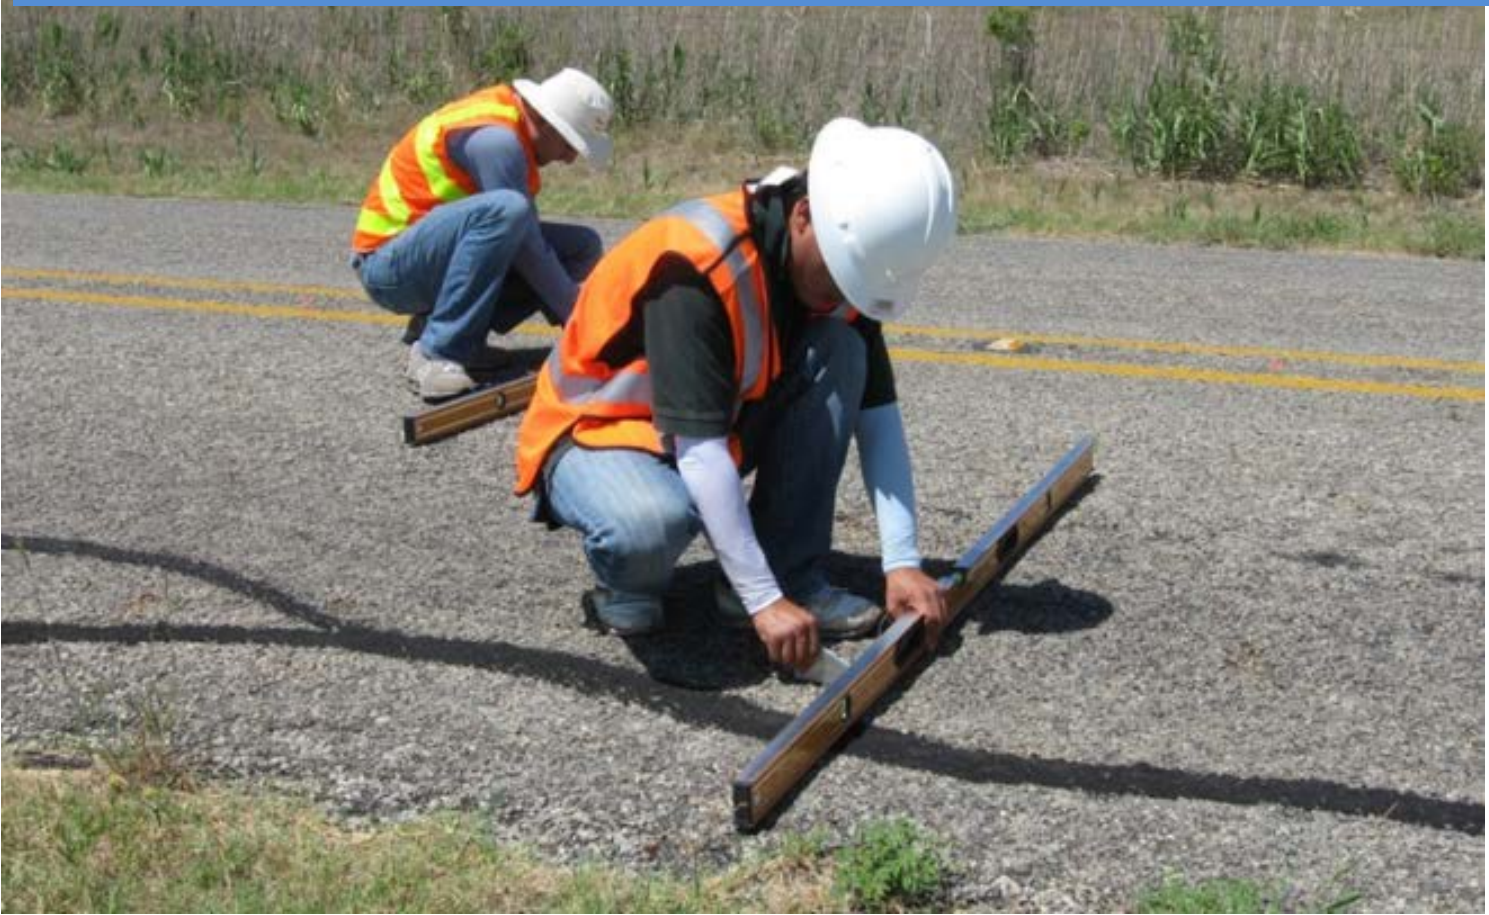
Collection of Reference Transverse Profiles

Manual 6' straight edge rut depth measurements
222 measurements per test section – over 5,200 measurements total

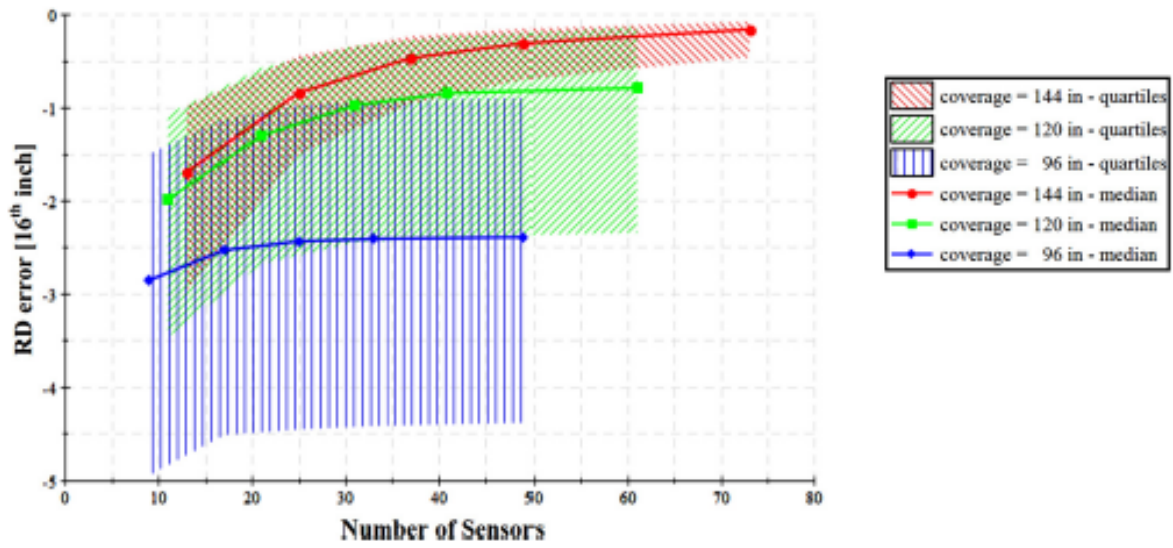
Comparison of Rut Depth Values

Accuracy (1/16 in.)	Precision (1/16 in.)	$\beta_{RD} = \Delta RD_{error} / \Delta RD$
CAS 1	-0.83	3.14	0.10
CAS 2	-0.87	2.52	0.15
CAS 3	-0.99	2.67	0.09
CAS 4	-2.45	5.22	0.58
CAS 5	-3.10	4.37	0.46
