CS8800 WALKING PROFILER

CS8800 DESIGN

CS8800 Design Specification

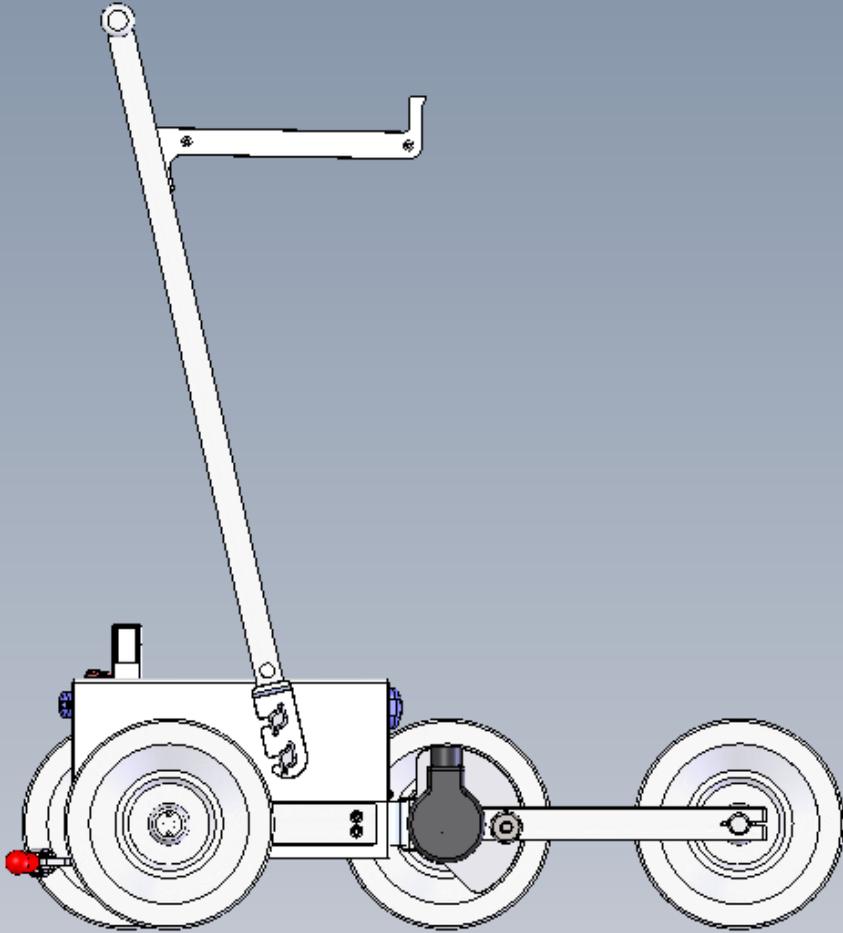
▲ Side ▲

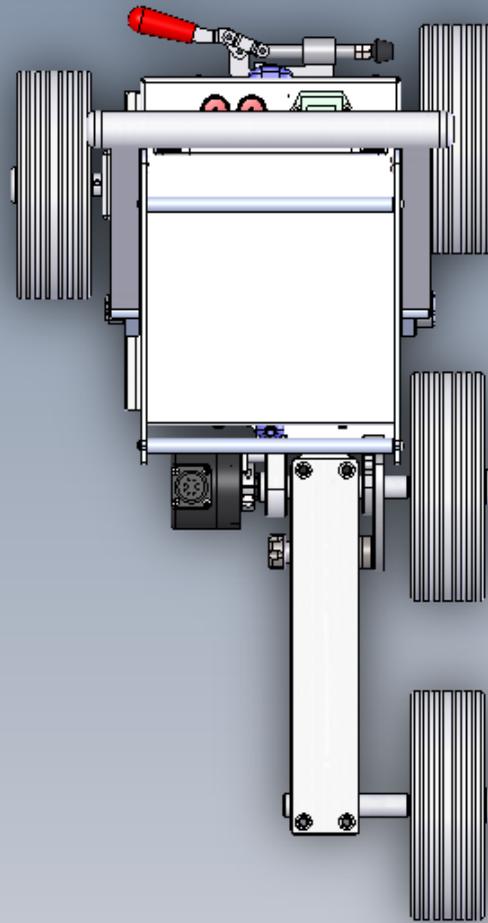
▲ Top ▲

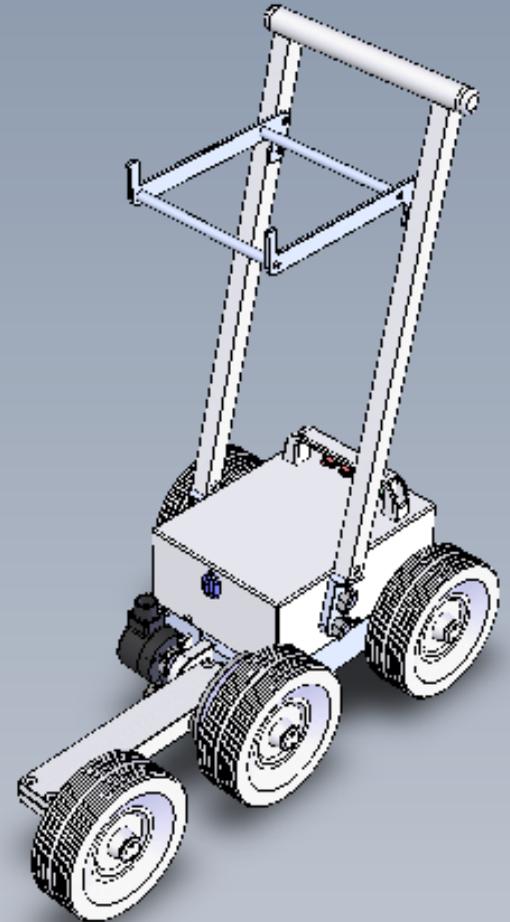
▲ Isometric ▲

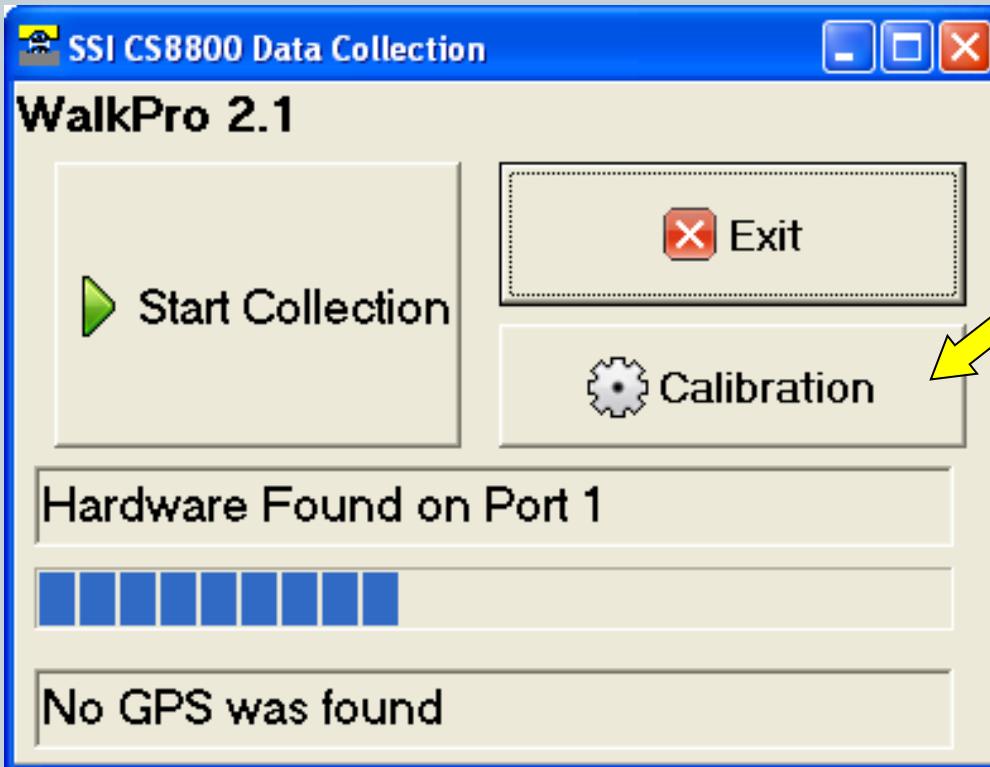
▲ Hardware Detection/Diagnostics ▲

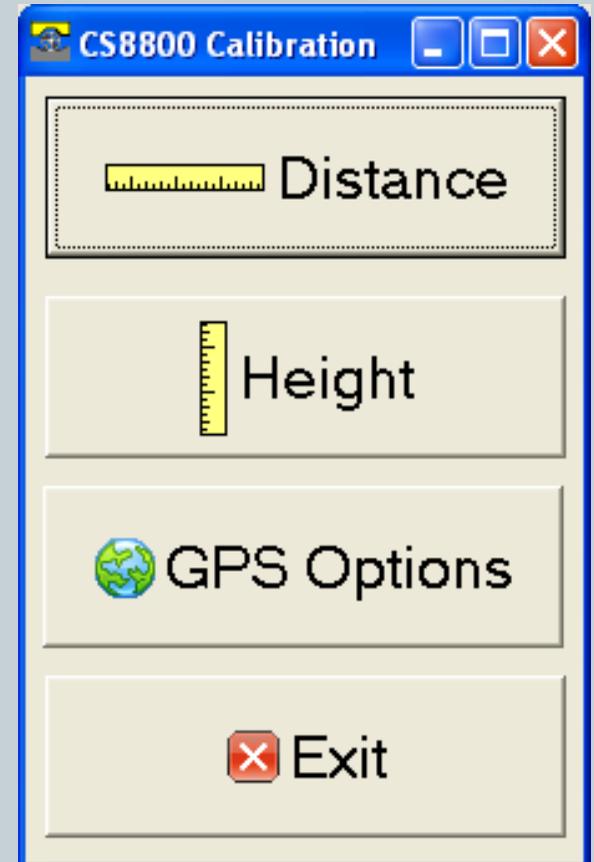
▲ Calibration Options ▲

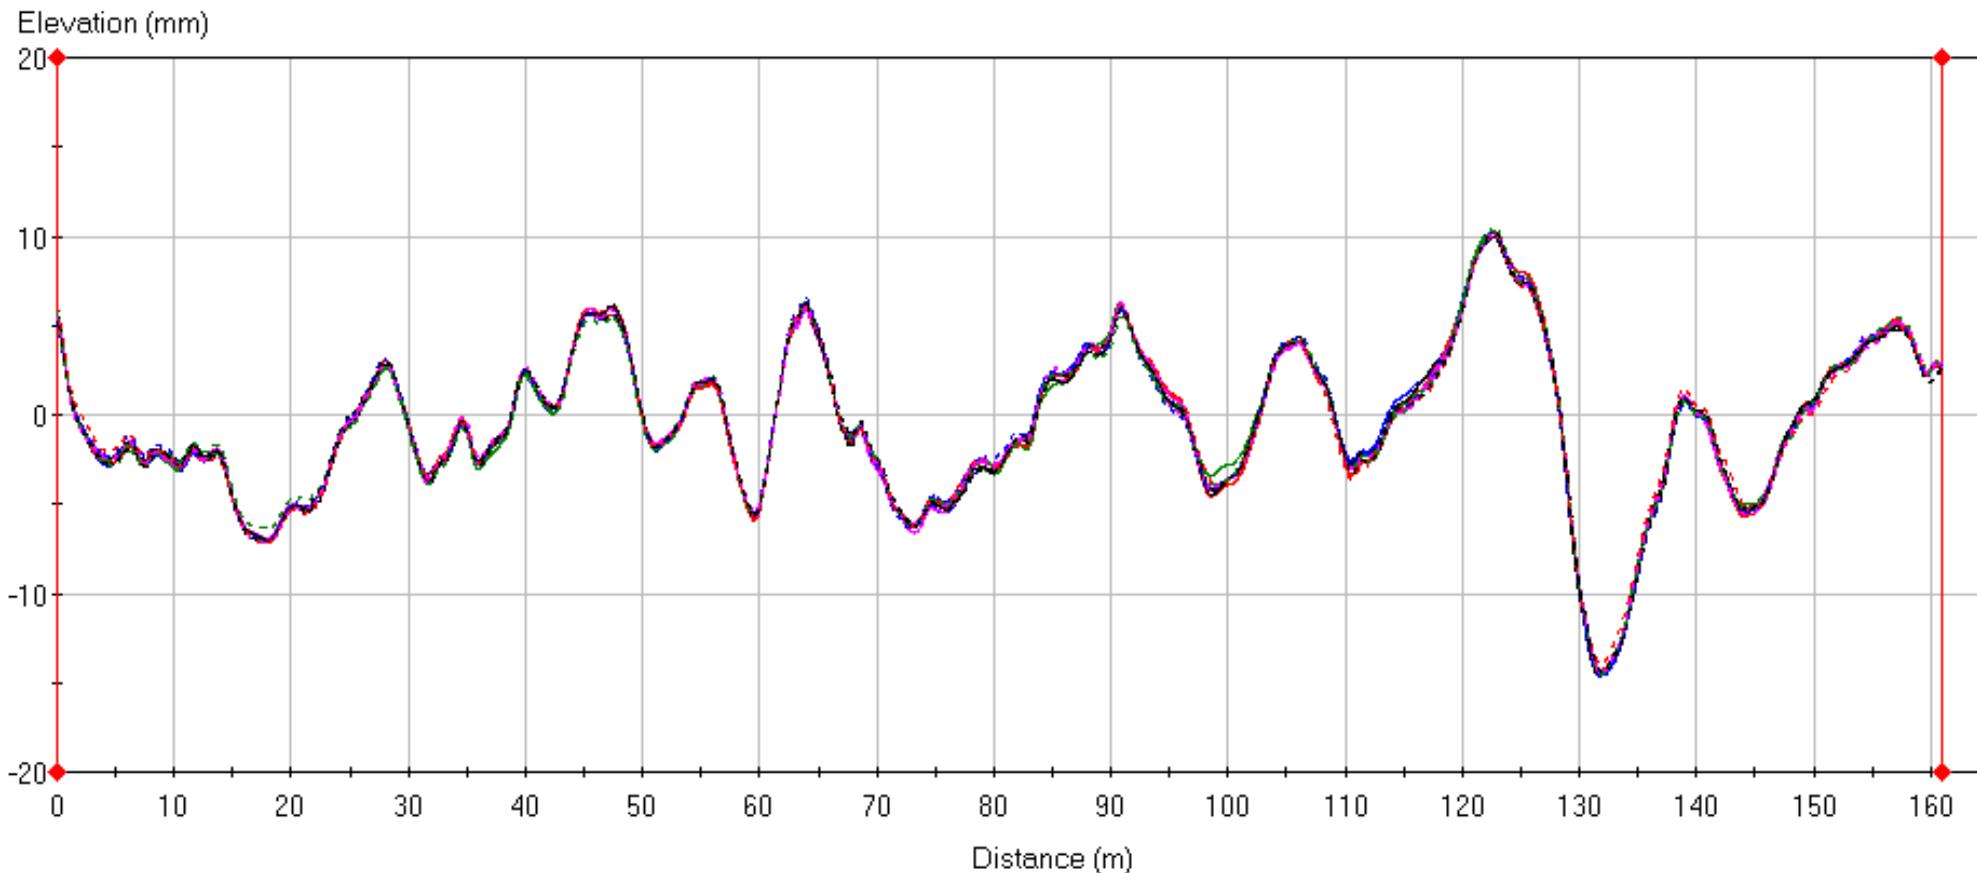
CS8800 Performance

▲ August 2008: Passed .985 IRI Profile Repeatability Threshold
for FHWA Reference Profiling Device Qualification ▲

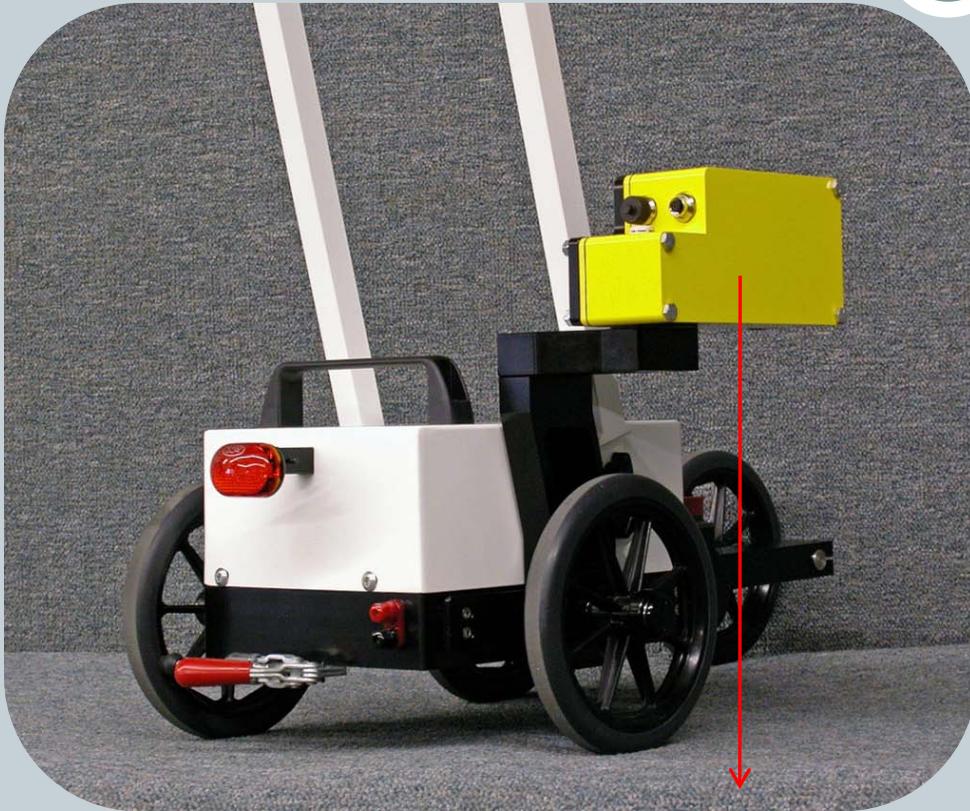
Simultaneous Collection of Surface Profile Data and Texture Content

▲ Line Scanning LMI RoLine or Bytewise RoadMap) for 3-Dimensional Texture Data ▲

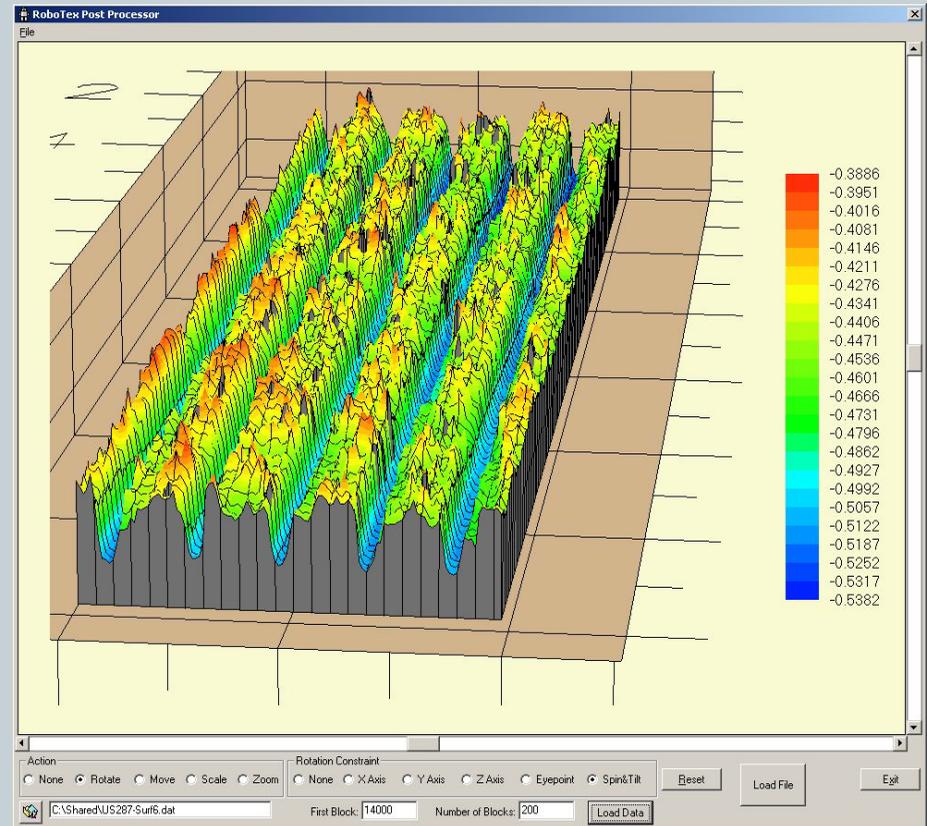
▲ 3-D Texture Imagery ▲

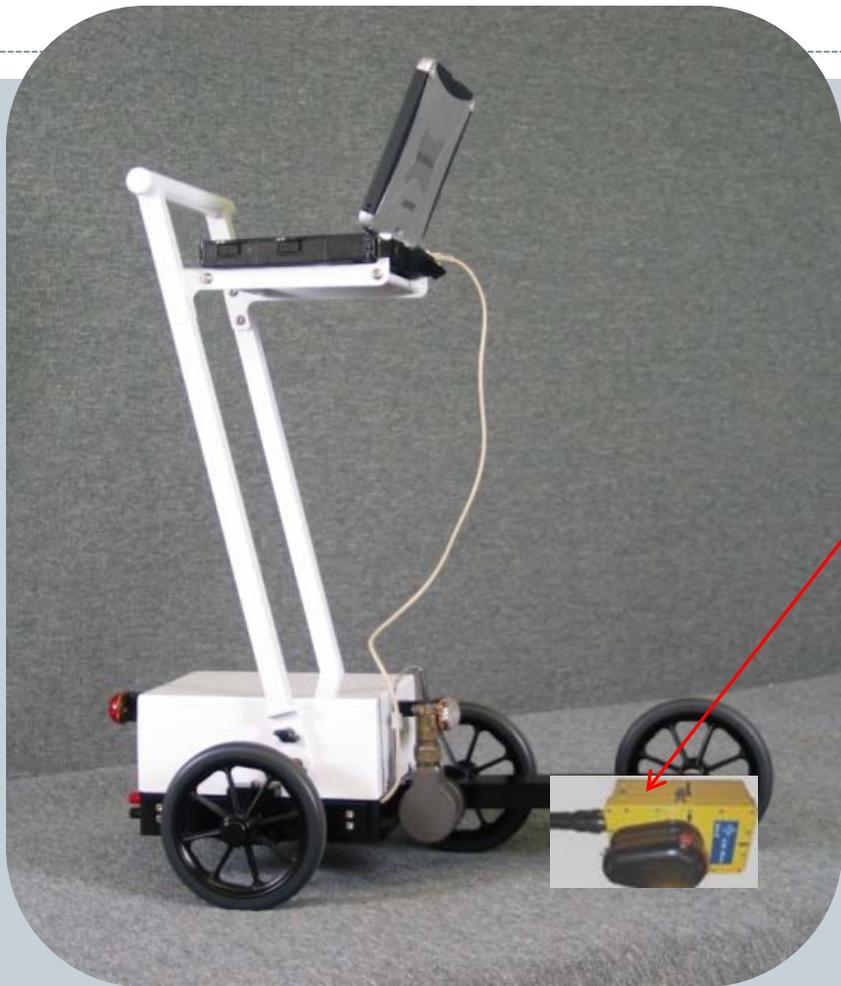
Simultaneous Collection of Surface Profile Data and GPR Content

Variable Frequency GPR Antennas Attach to CS8800 for Different GPR Applications

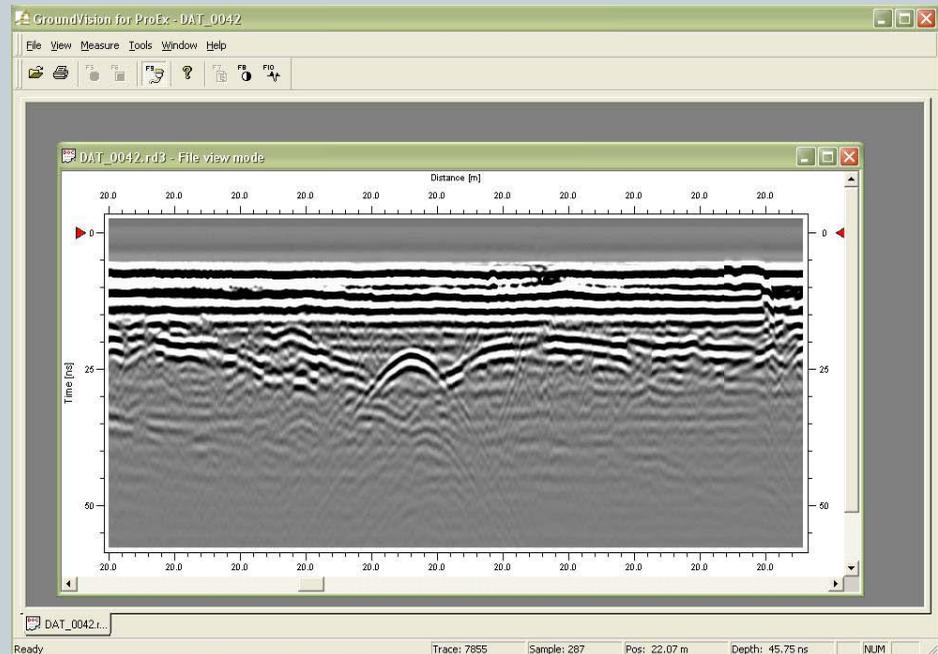
▲ GPR Imagery on Toughbook with Windows Software ▲

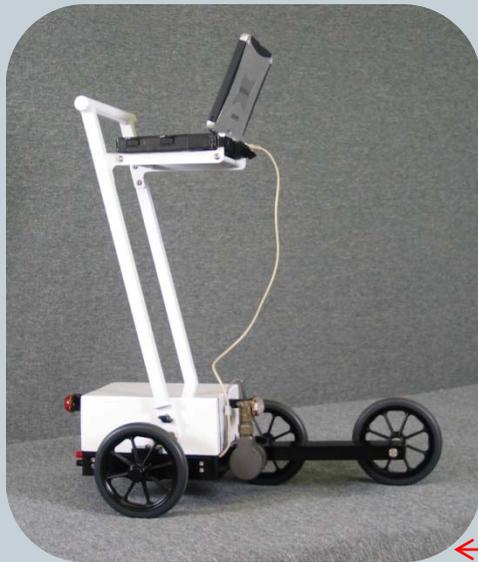
Simultaneous Data
Collection: Profiling
System and GPS /RTK

Toughbook Computer

RF Radio
For RTK
Corrections

High
Resolution GPS
Receiver
Embedded into
Profiling
System
